RE: 35 Loma Vista Lane Arborist Report and Tentative Map Review and Responses to County Planning Comments

ARBORIST REPORT

35 LOMA VISTA LANE
BURLINGAME
(PLN2018-00098)

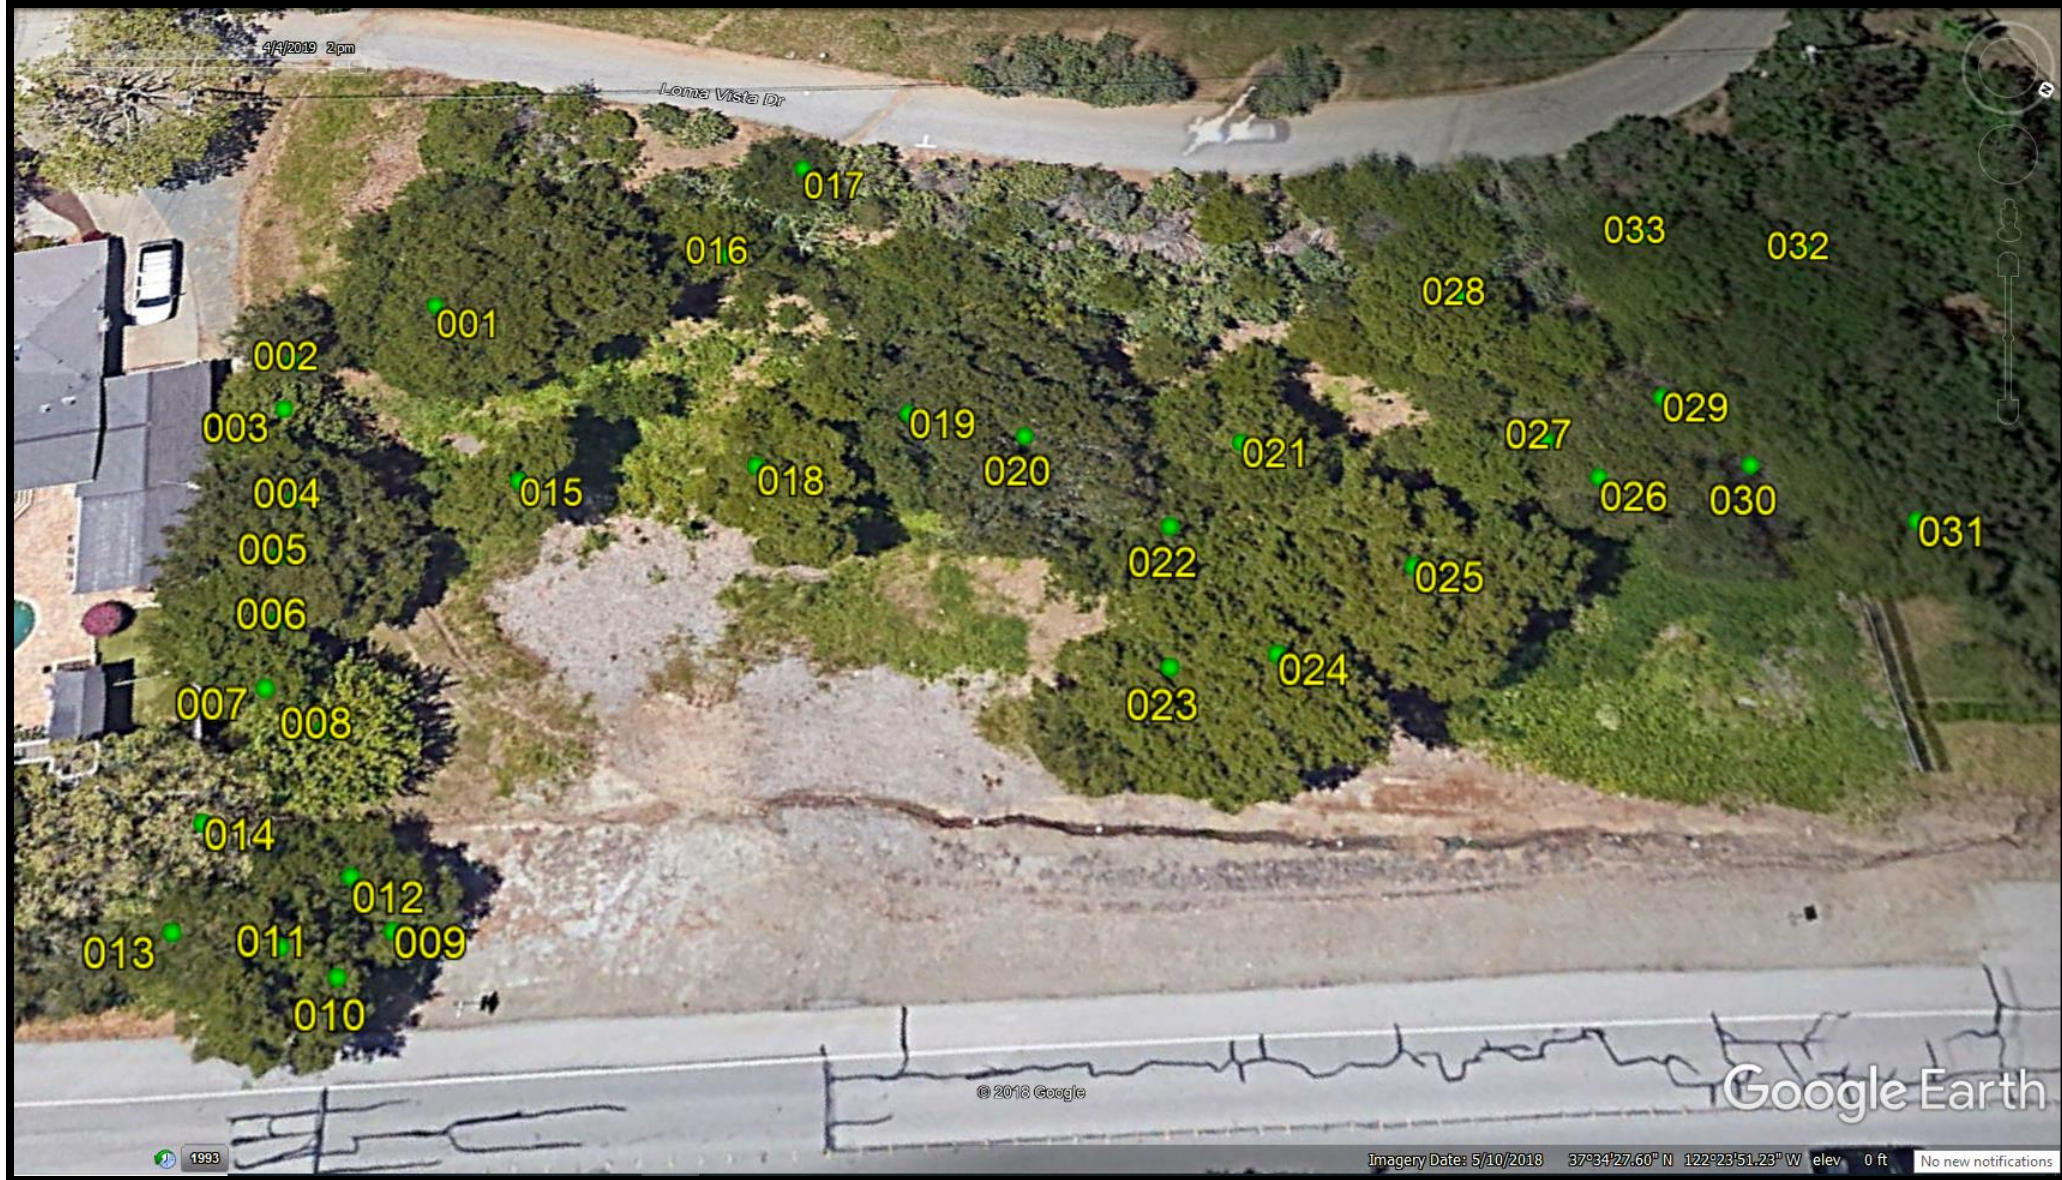
Tree Locations (Not to scale - For illustration purposes only)

Mapping: I used a handheld Garmin GPS (Global Positioning System) to plot tree locations. Reference Exhibit B for a screen shot of the tree location map. This data is intended to assist with tree location and is not intended to be of survey precision as GPS capabilities are limited. Accuracy may vary as a result of weather, canopy cover, or other obstructions.
