# Advanced Tree Care

January 25, 2023

Site: 890 Upland Rd, Redwood City

Re: 2 Valley oaks at front of property

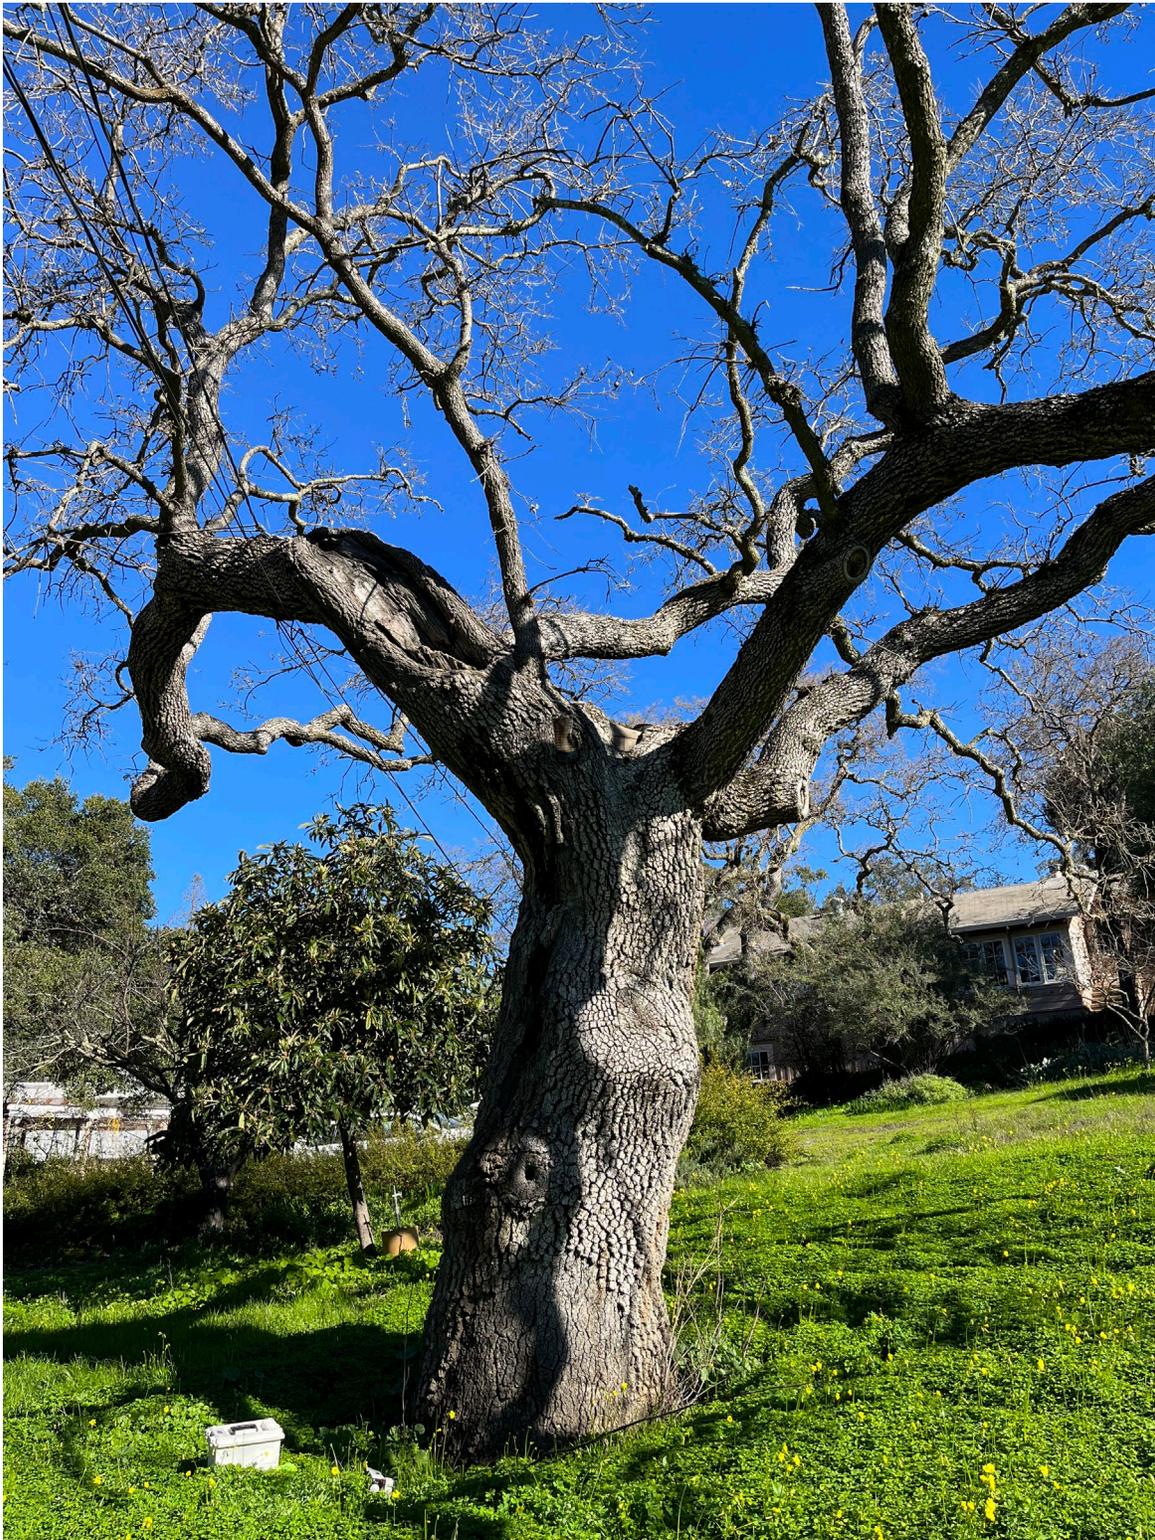
Valley oak # 3

The valley oak is in fair health but poor condition. The **canopy** is showing fair vigor with buds about to break in the upper canopy. The structure of the tree is very poor. The tree has a main trunk to 12 feet in height at the top of which one large scaffold limb grows towards the north and several smaller scaffold limbs radiate out in other directions. The largest scaffold limb towards the north has a large scar and **cavity** where a previous large limb failed. The union of all the main scaffold limbs has a large, exposed area of concrete suggesting there is a large cavity down the trunk from a previous limb failure. There are many cavities throughout the scaffold limbs of the tree with pockets of **decay**. The powerlines that lead to the house are attached to the tree. There are scars and cavities on the trunk. There are 2 cavities at the base of the tree in the **root crown**. I inserted a probe into the cavities which extend a foot inside the trunk before hitting wood.

The tree is in fair health but poor condition. The decay in the lower trunk is acceptable, however the visible decay at the top of the trunk, at a critical point in the structure of the tree is unacceptable and at high risk of failure. There is further decay and cavities throughout the main scaffold limbs of the tree which may lead to further large limb failure. The root crown is compromised with visible decay.

On a tree of this age and size, now in its declining years, I believe the decay will continue to spread, decreasing the thickness of the sound wood in the trunk and scaffold limbs. The tree could be heavily pruned, this would lead to further openings for decay and lead in an unsightly tree. I recommend that this tree be removed.

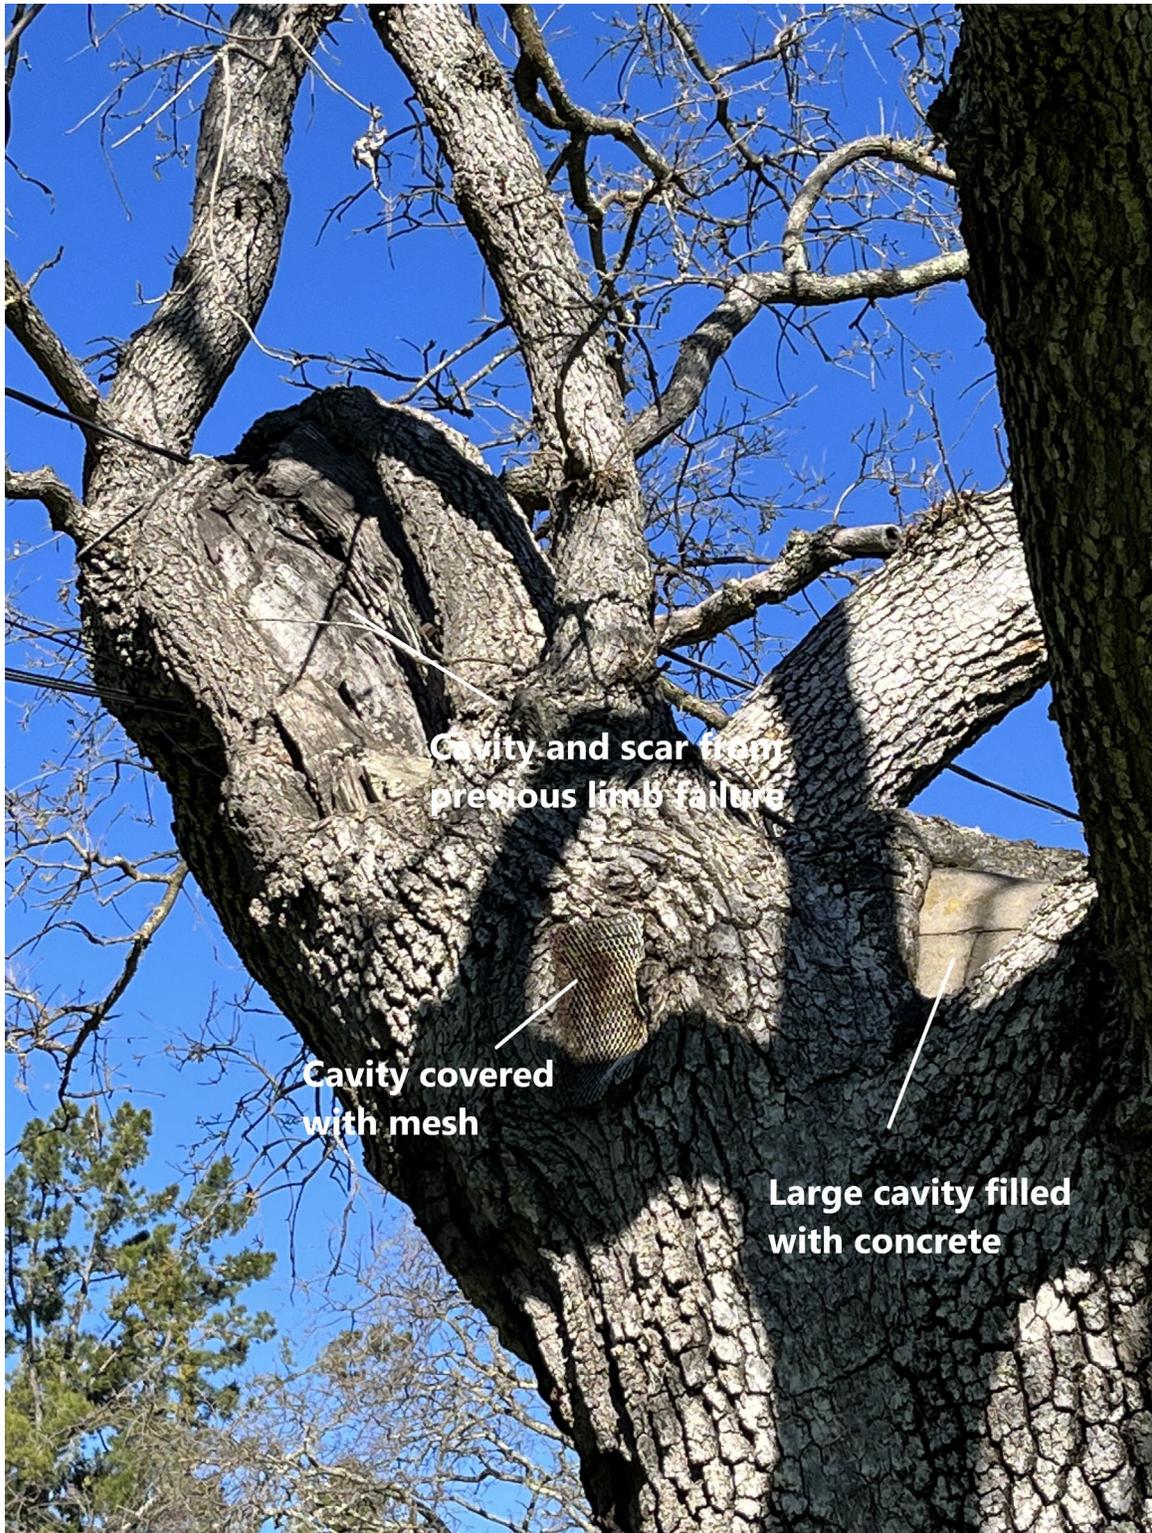
Decay and cavities at critical branch union

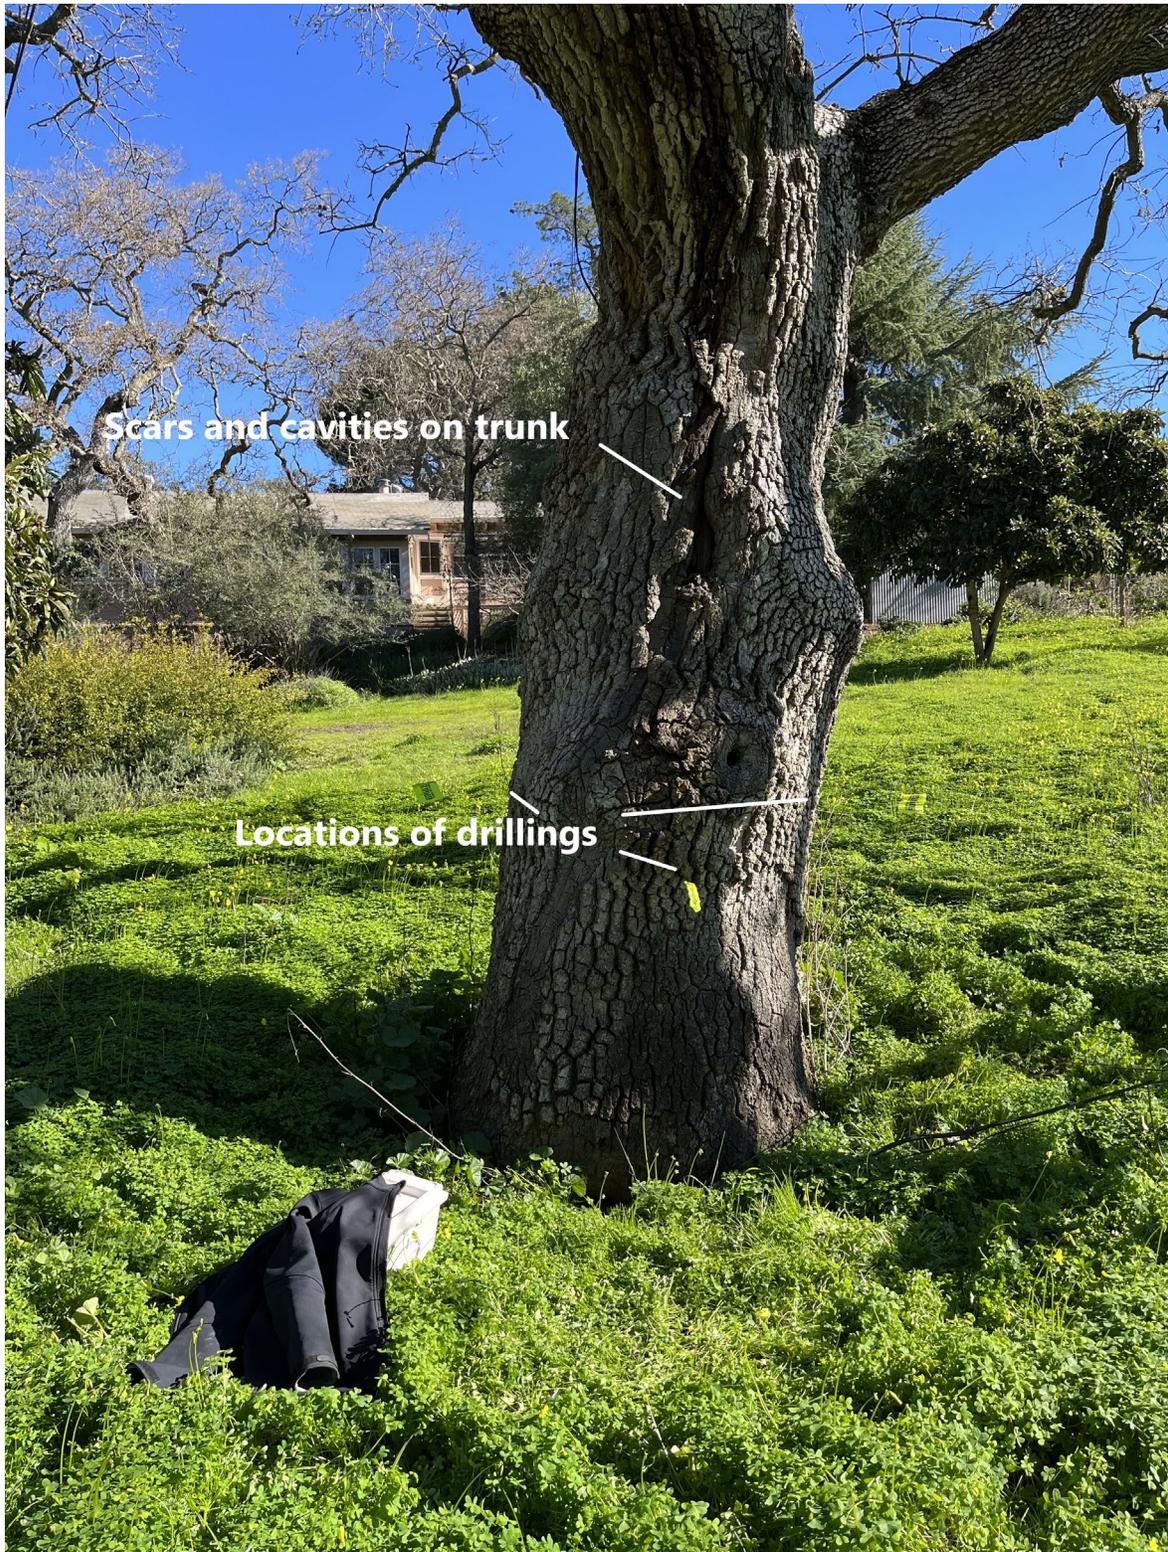
I sounded the trunk with a hickory mallet and found the most decayed areas at around 4 feet above grade. I resistographed the lower trunk on the north, south, east and west sides of the tree at approximately 4 feet above grade. I found decay at 7", 10", 14" and 14.5" respectively, inside the trunk. This suggests an uneven column of decay with an average wall thickness of approximately 10". This is an acceptable level of decay to support a tree of this size and species with good sound wood at approximately 1/5<sup>th</sup> of the diameter of the tree.

Scars and cavities on trunk. Locations of resistograph drillings.

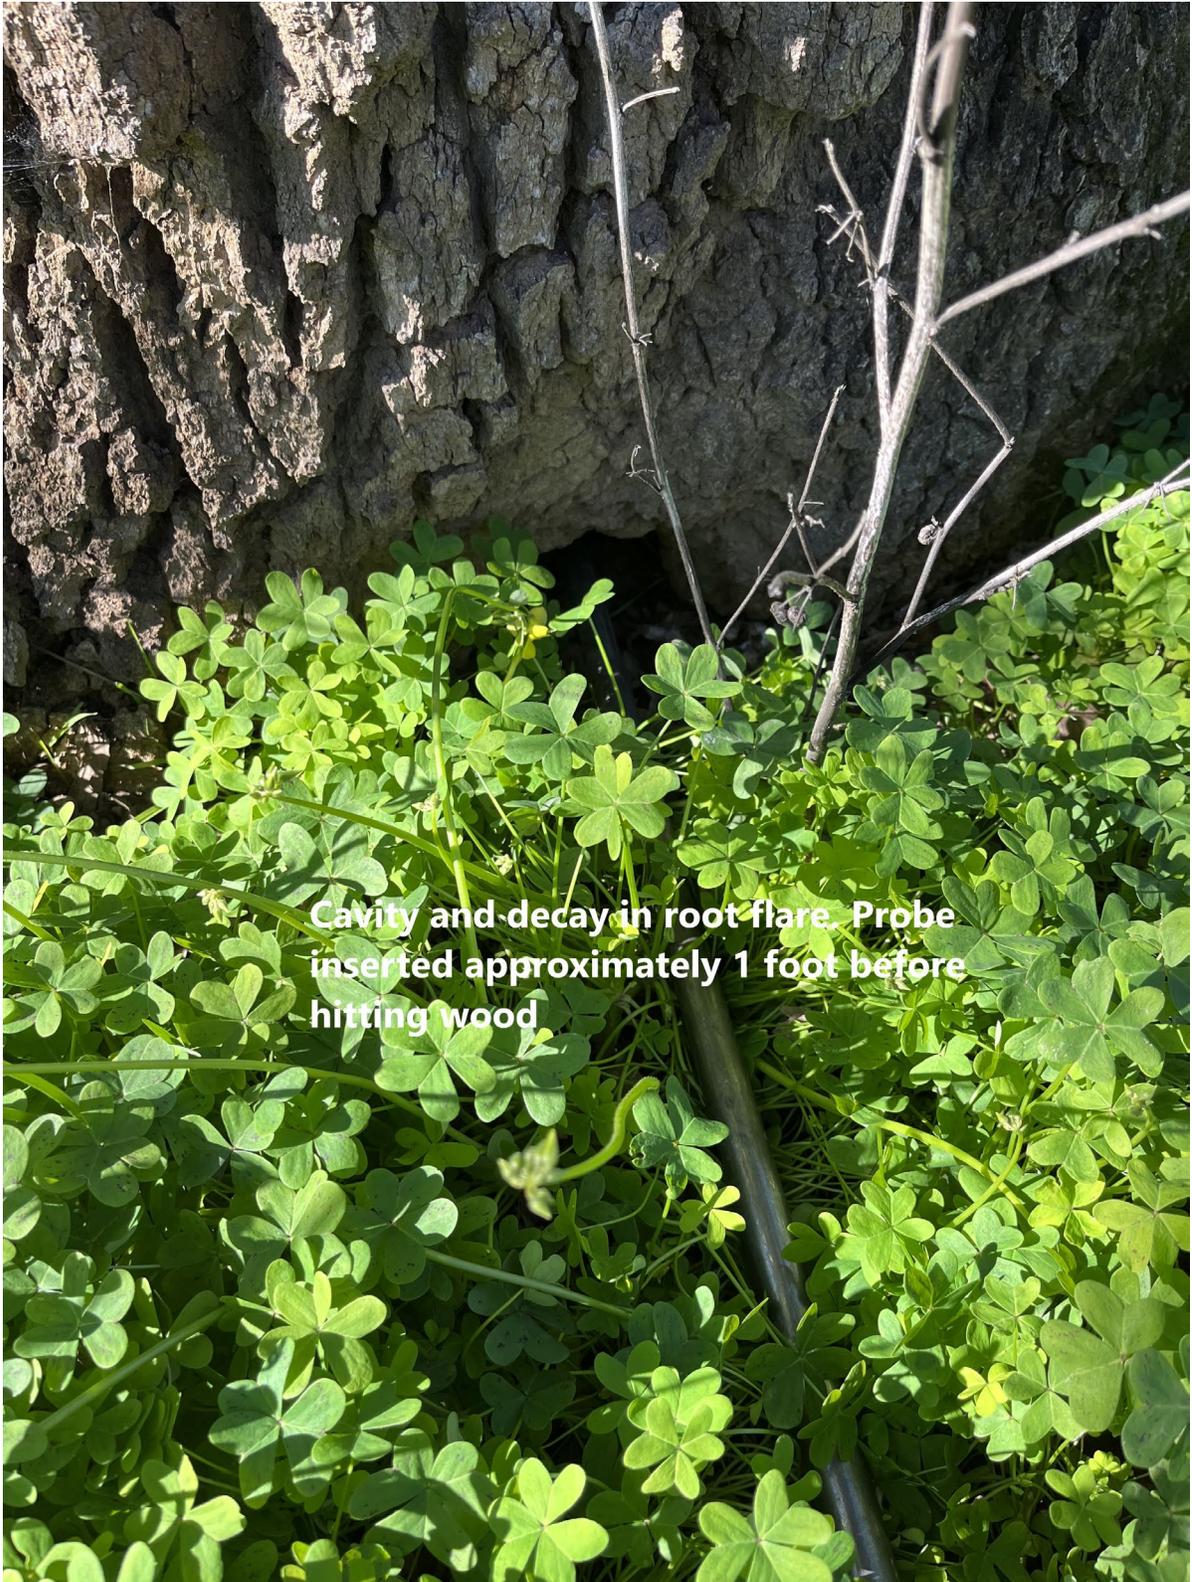
One of two similar cavities in root flare

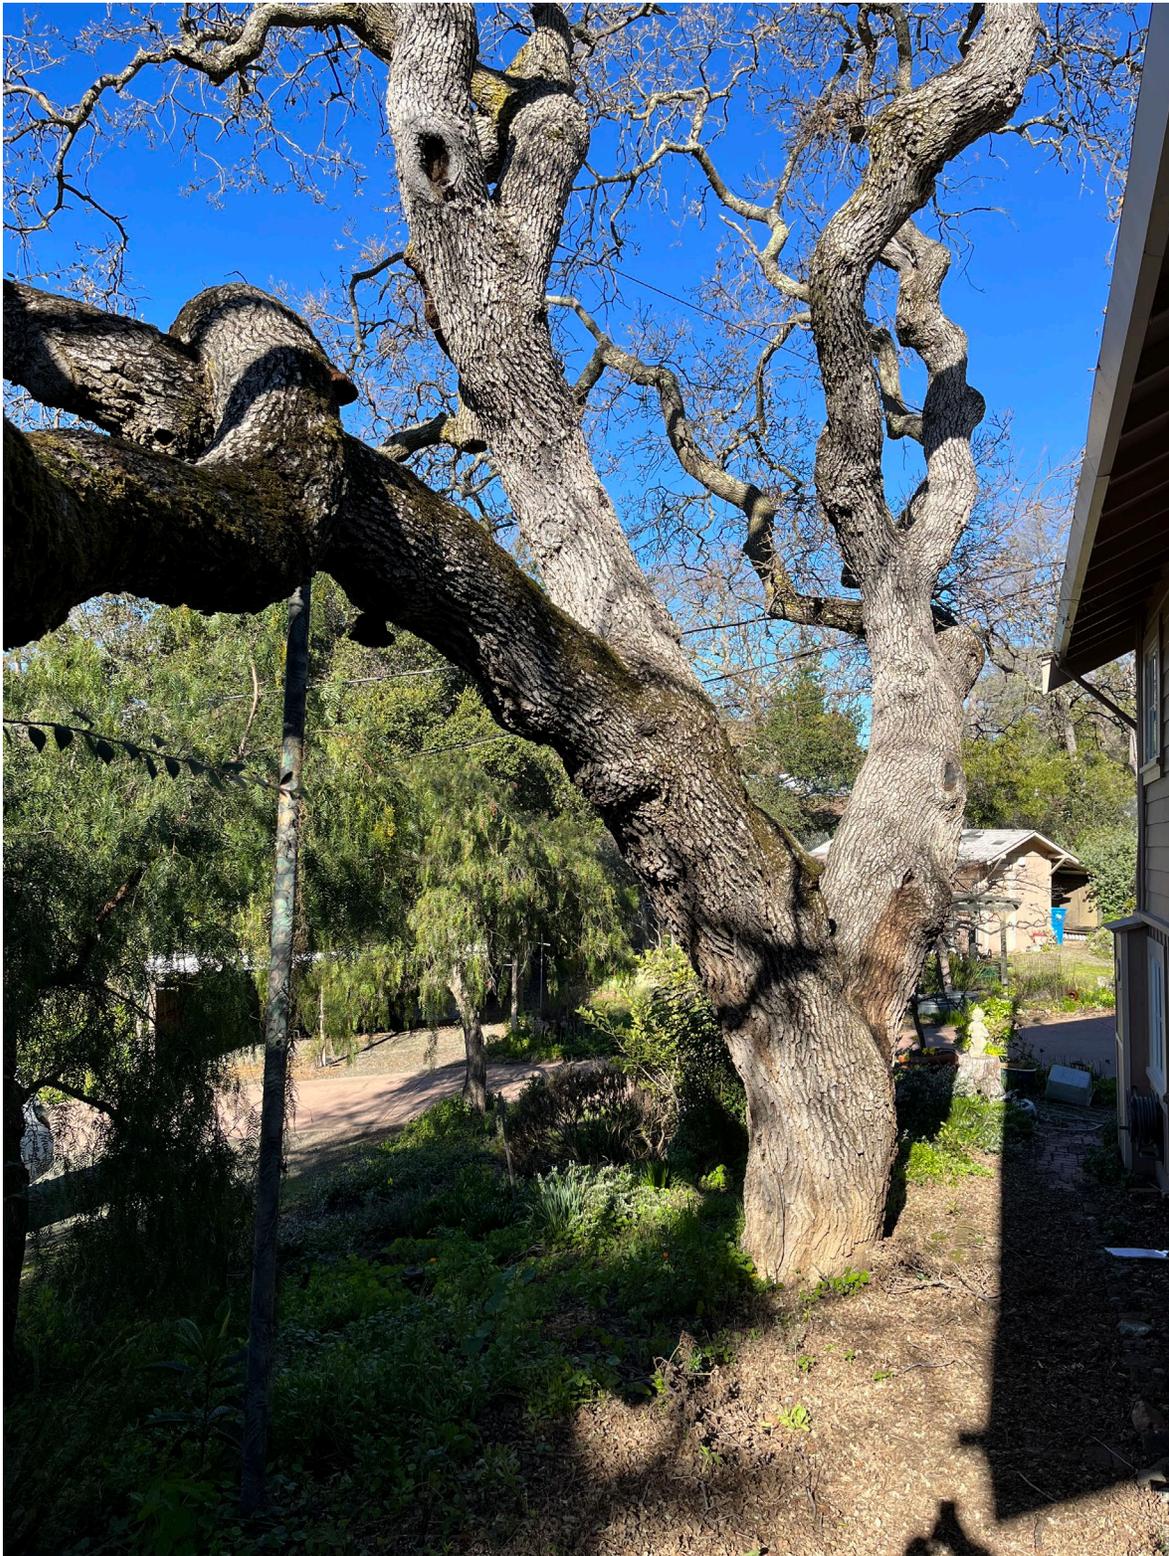
Valley oak # 26

The valley oak is in fair health but poor condition. The canopy is showing fair vigor with buds about to break in the upper canopy. The structure of the tree is very poor. The tree bifurcates into 2 trunks at approximately 5 feet above grade. One trunk stays mostly vertical whilst the second trunk heads out horizontally and then develops a second vertical trunk which is cabled to the main trunk. The horizontal trunk is propped with a 2 ½" diameter steel pipe as a support. The trunks have many open cavities and decay. The root crown is partially buried but there are no signs of decay or oak root fungus.

The tree is in fair health but poor condition with a moderate to high risk of failure. On a tree of this age and size, now in its declining years, I believe the decay will continue to spread, decreasing the thickness of the sound wood in the trunk walls further and leading to failure. The tree could be heavily pruned to reduce the burden on the trunks, this would lead to further openings for decay and lead in an unsightly tree. I recommend that this tree be removed.

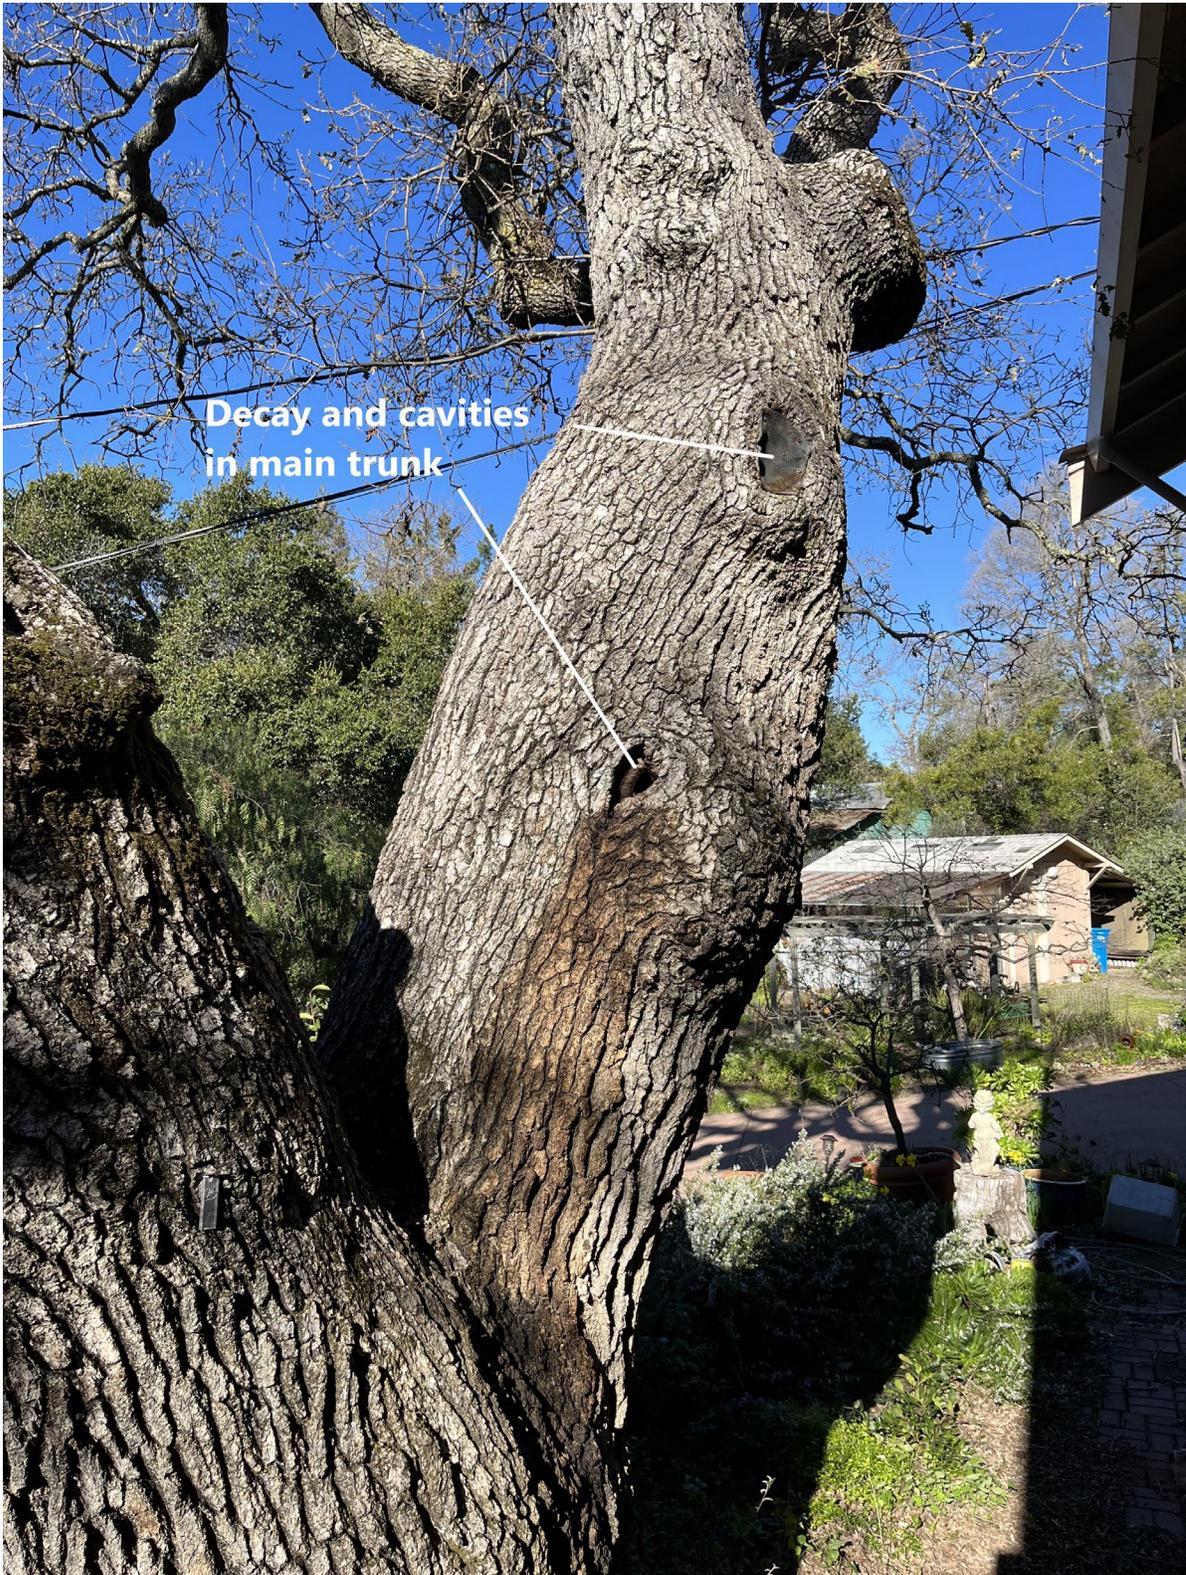
Decay and cavities in main trunk

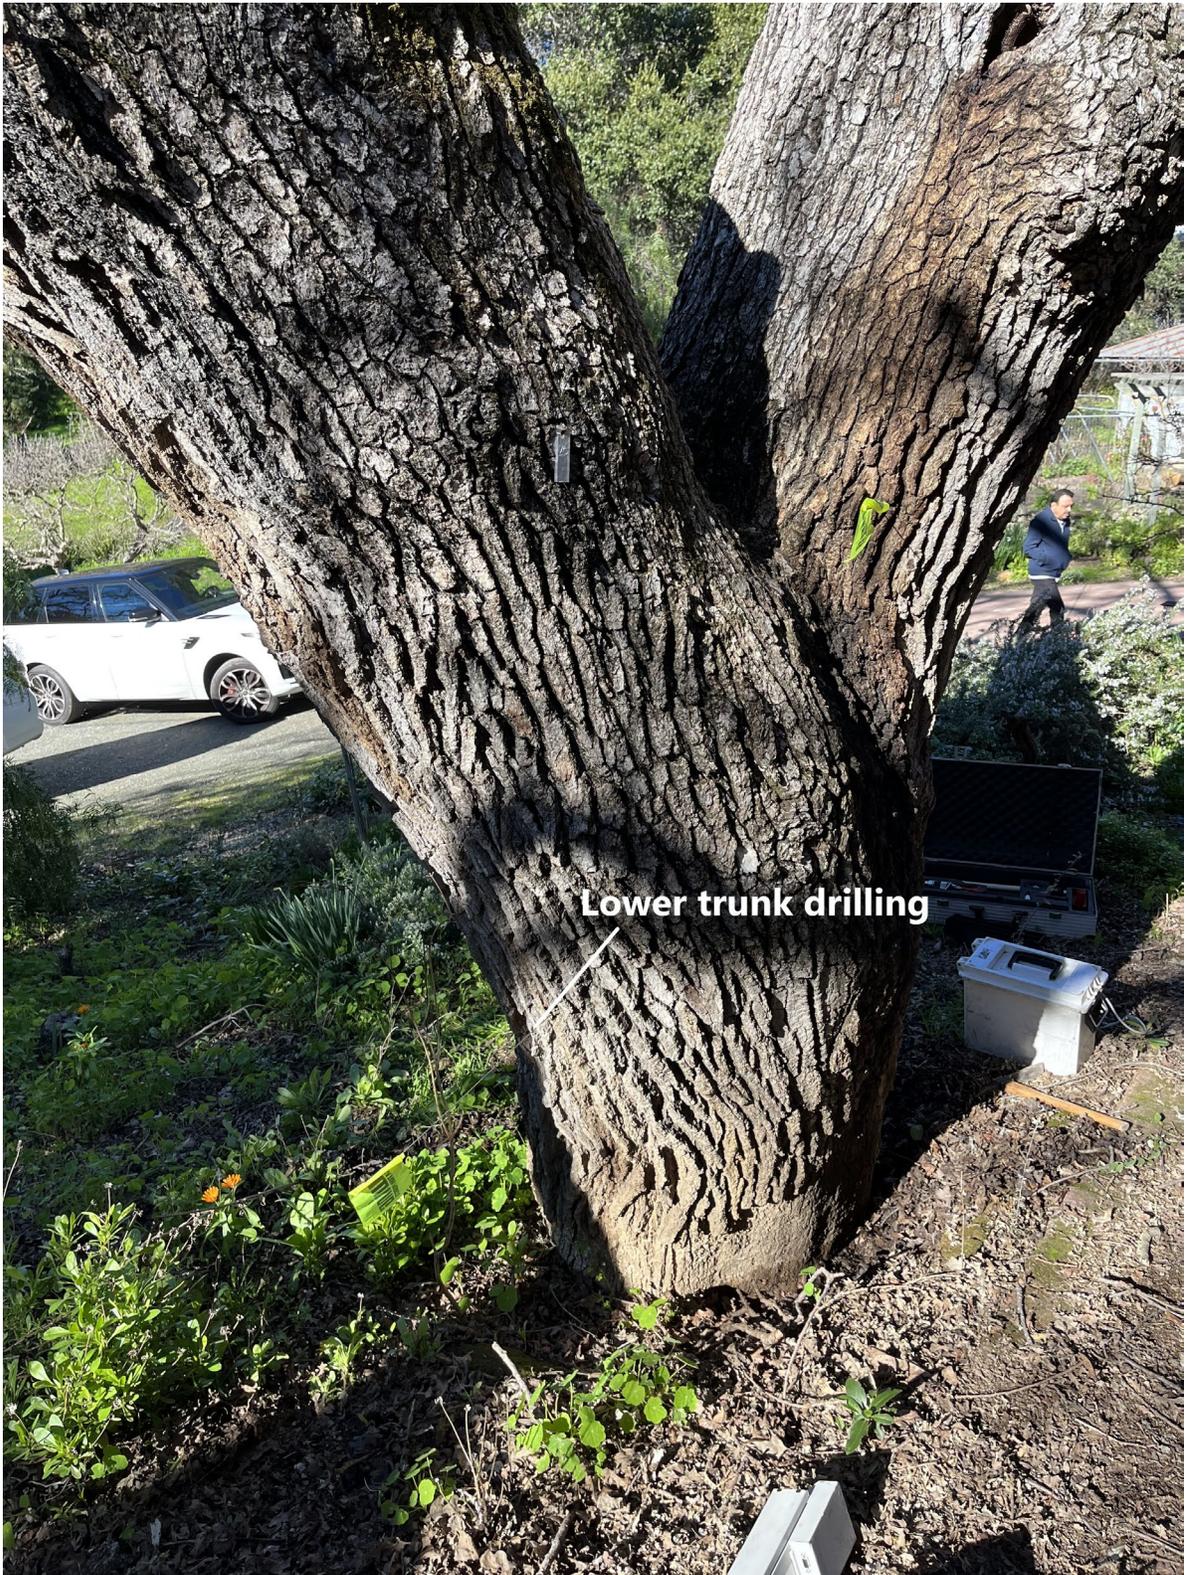
I resistographed the lower trunk on the north and south side at 1 foot above grade and found decay and concrete at approximately 11 inches into the trunk on both sides which means there is a column of decay, centrally located within the trunk of approximately 13" diameter at 1 foot above grade. The thickness and location of the sound wood is acceptable and not likely to fail in a tree of this size and age. I then resistographed the main trunk on the north and south side of the trunk above the bifurcation where the trunk diameter is 28.0" and found decay at 3" and 4" into the trunk. The thickness of the sound wood is below 1/6<sup>th</sup> diameter of the trunk and there are several open cavities which also affect the overall strength of the trunk. The trunk is at a moderate to high risk of failure. Resistograph readings can be found at the end of this report.

Location of lower trunk resistograph drilling

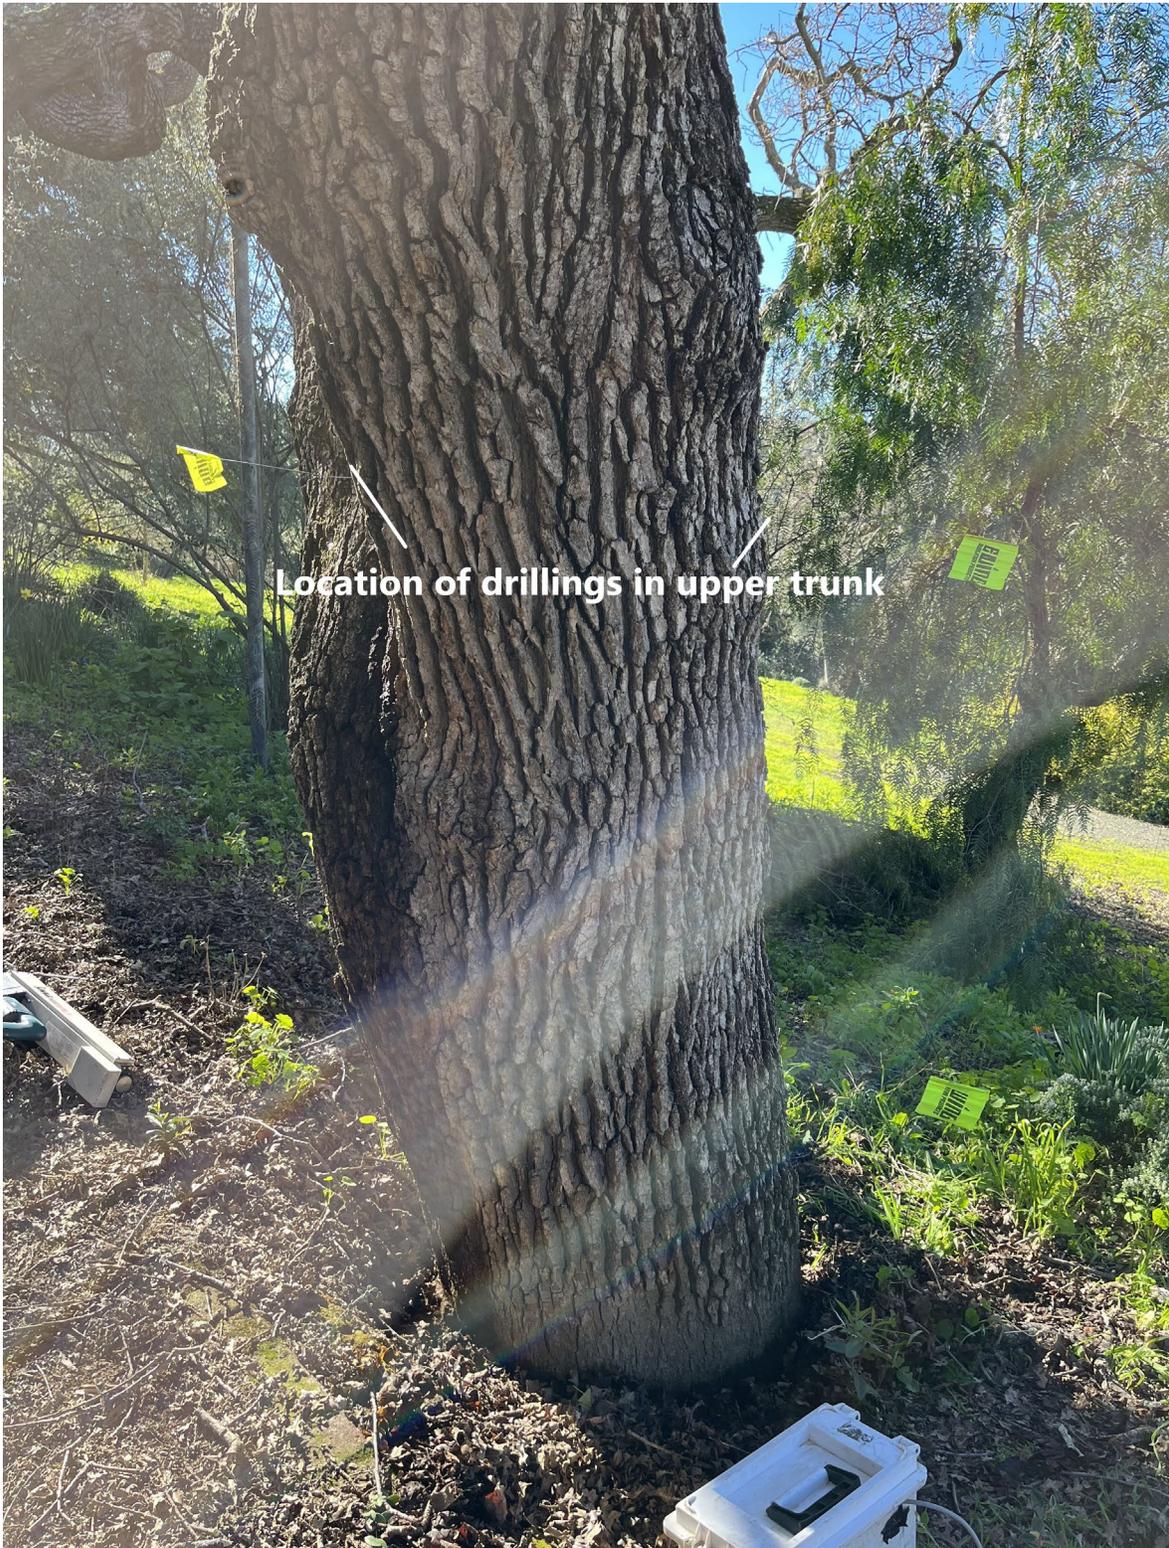
Location of drillings on upper trunk
